Manhole Inspection Summary

Manhole # S29II_013MH

Location Address: **1520 MCMECHEN ST**

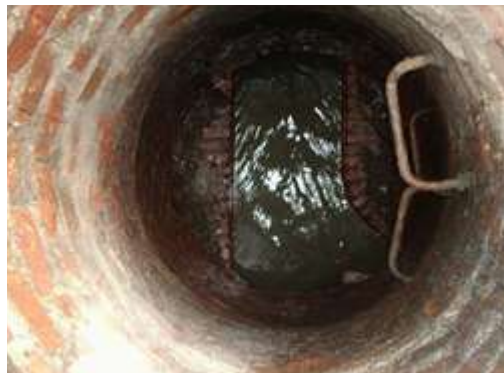
Top View

☒ **Debris** (not Condition related)

Count: **5** Missing: **0** ☒ **Corroded**

☒ **Evidence Of Surcharge**

Evidence of surcharge - Bench debris.
Corroded steps.

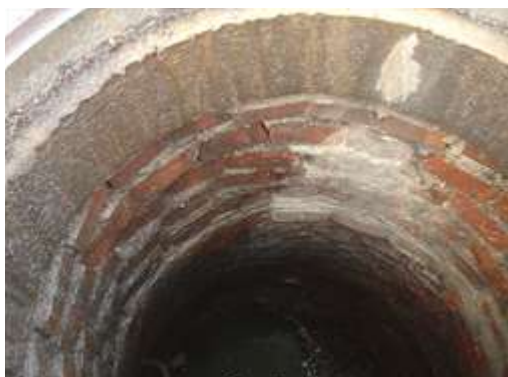
Defect

☒ **Leaks**

Condition: ☐ Sound ☐ Cracked ☐ Root Intrusion ☐ Loose Brick ☒ **Deteriorated**

Infiltration: ☐ None ☒ **Joint** ☐ Cracks ☒ **Mortar** ☐ Roots ☐ Wall

Frame leaks. Adjustment deterioration
and infiltration. Corbel and Barrel
infiltration - other side.

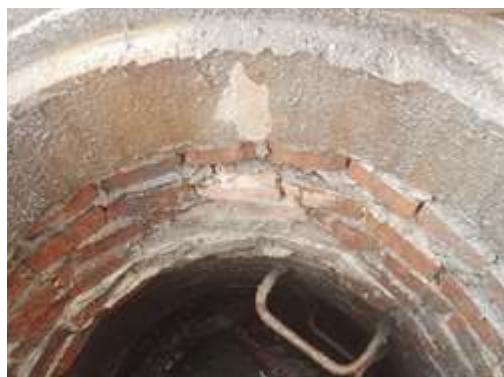
Defect

Infiltration: ☐ None ☐ Joint ☐ Cracks ☒ **Mortar** ☐ Roots ☒ **Wall**

Frame leaks. Adjustment deterioration
and infiltration. Corbel and Barrel
infiltration.

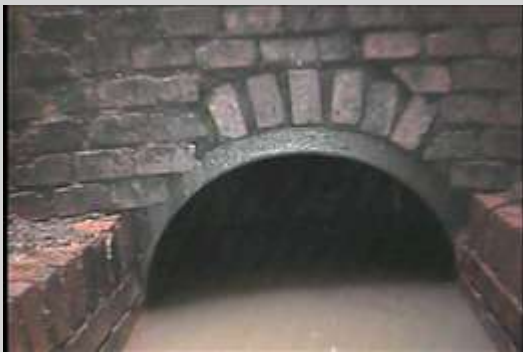
21 in. Circular Gravity Sewer Pipe Out @ 12 O'Clock

Condition: ☐ Sound ☐ Cracked ☐ Root Intrusion ☒ **Deteriorated** ☐ Leaks ☐ Debris

Channel deterioration.

Infiltration: **Evidence** Pipe Seal Cond: **Unknown**

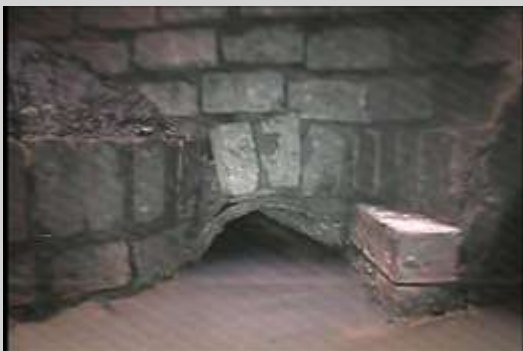
8 in. Circular Gravity Sewer Pipe In @ 3 O'Clock

Infiltration: **Evidence** Pipe Seal Cond: **Unknown**

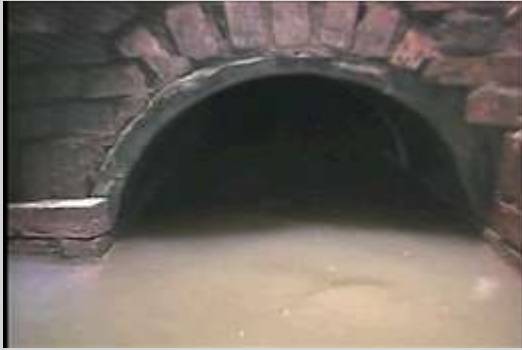
24 in. Circular Gravity Sewer

Infiltration: **Evidence**
